CONSULTING ARBORIST

March 27, 2006

RE: Coral tree at Radio Square, Santa Barbara

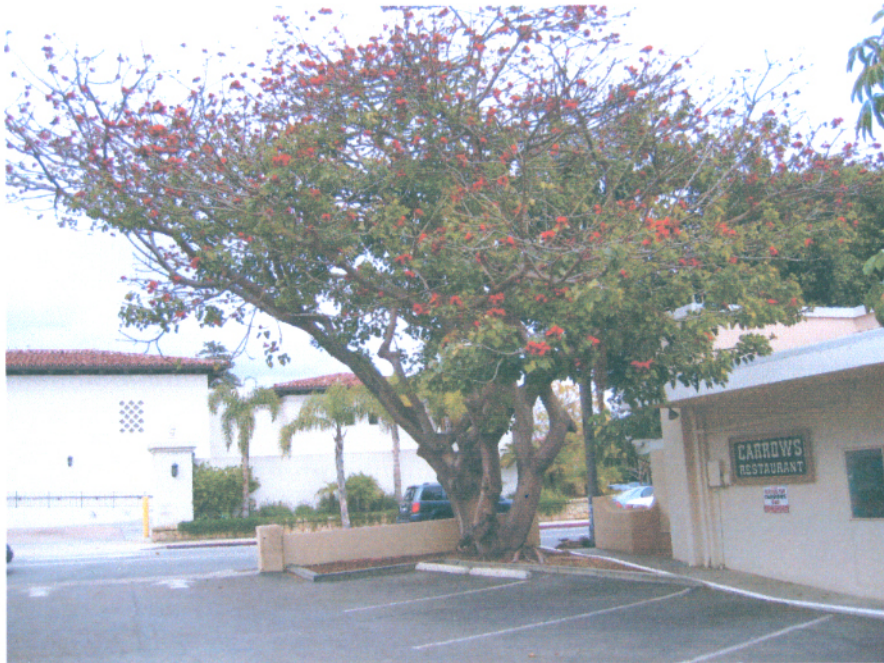
Figure 1: A view of the coral tree looking to the southeast.

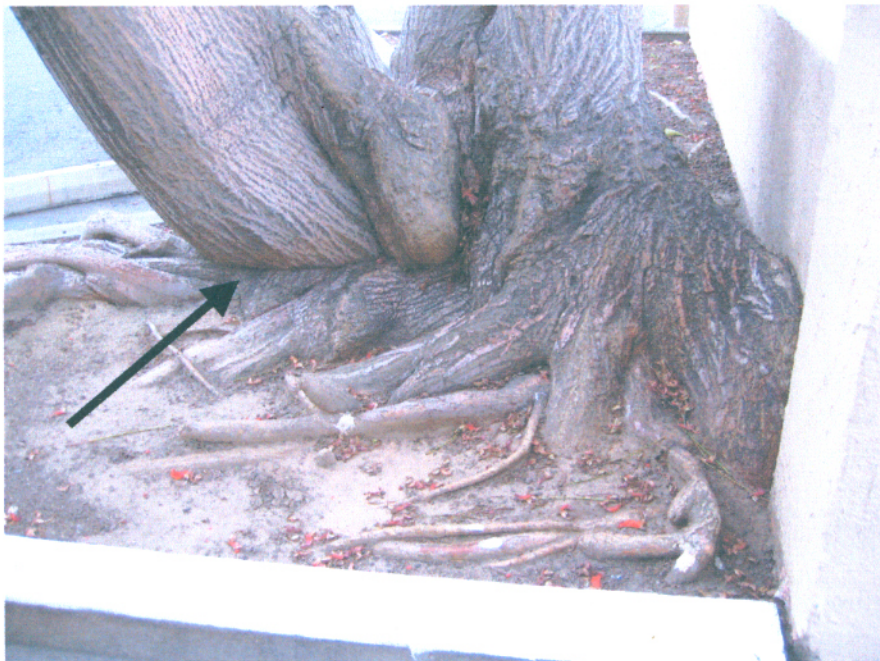
Although this tree is biologically healthy, the conflicting trunks and roots are a sure indication of future structural problems. Figure #2 below, shows how the western trunk is being girdled by rapid growth of lateral roots. Figure #5 points to how the increasing diameter of trunk growth, squeezes each other for space, thus causing an anatomical weakness (called included bark) and a weak attachment between trunks.

Figure 2: Looking to the north, the trunk is growing into the wall to the east. The arrow points to the western trunk being girdled by root growth.

1. Remove the tree and replace it. If a coral tree is preferred, the *erythrina coralloides* is an attractive but slower growing species (it is also deciduous). A conical or upright shaped tree would be best for this planting site and should be installed with a chemical root barrier.

2. Demolish all concrete, asphalt and stucco around the tree by hand.
3. Any encountered roots that are greater than 1/2" in diameter should be cut, by hand, back to at least 1' inside of the planting space.
4. Install a chemical root barrier (bio barrier) to a 36" depth.
5. Install chain link fence at the edge of the tree's allowed area.

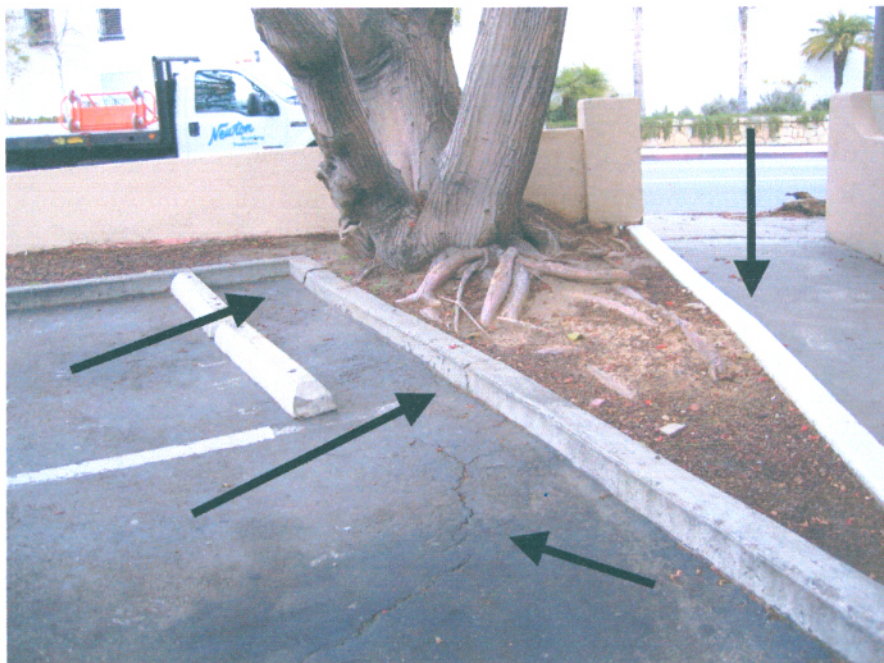
2. Based on the growth of the crown, it appears the tree is biologically healthy.
3. However, structurally, the tree is in poor condition.
4. This fast growing species is confined to a small triangular shaped planter in a parking lot that is approximately 8' by 17'. Exposed roots are evident and can be seen bulging at the curbs of the planter and girdling the western trunk. The eastern trunk of the tree is growing into the stucco wall, which will eventually conflict with the sidewalk. See figures.

Figure 3: Looking to the east, note the extensive root system and some of the damage to concrete and asphalt.

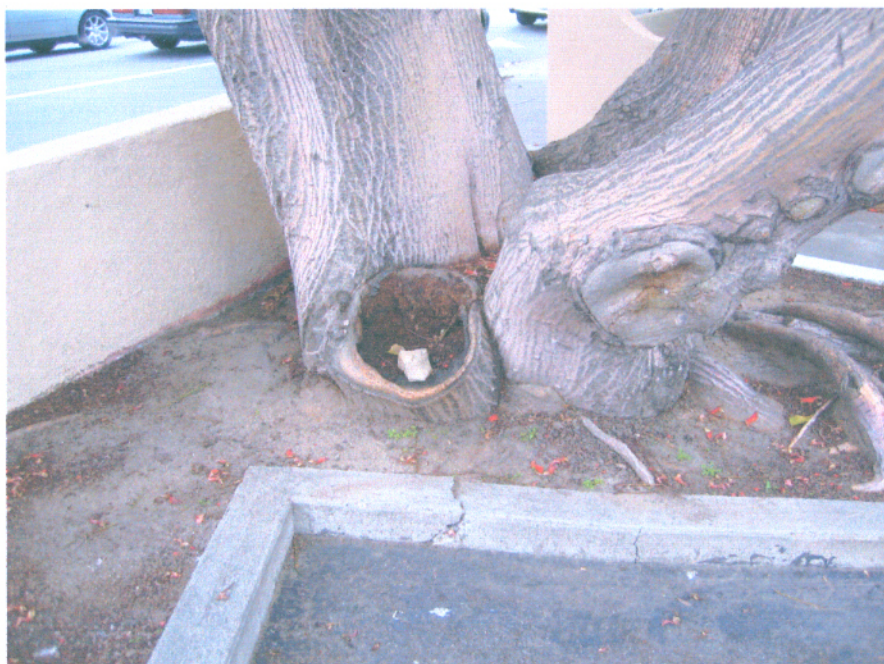
5. A small diameter trunk on the north side of the tree was removed several years ago, and the wood at the base of the cut has decomposed leaving a cavity.

The removed trunk on the north side of the tree shows decomposed wood (cavity) at the base of a pruning cut. Eventually, this decay moves into other parts of the porous wood and weakens the supporting heartwood. See figure #4.

Figure 4: Looking south at a cavity from an old pruning cut where one trunk was removed. Note how the wood has decomposed.

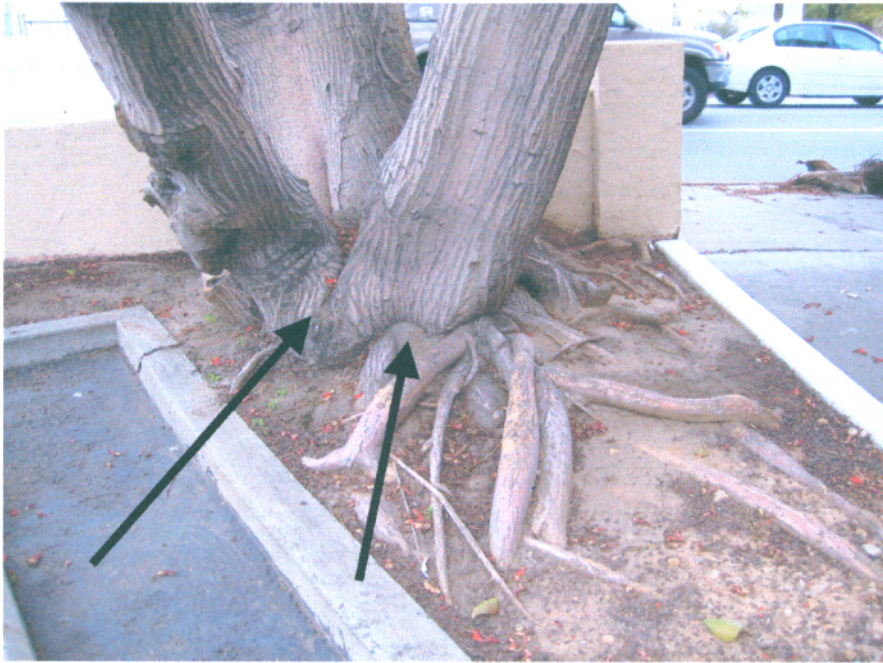
Figure 5: Another view of the co-dominant trunks and the included bark between trunks, and girdling roots (arrows).
